## EXPERIENCE WITH A SUBMERGED PIPE LINE IN THE PUERTO BARRIOS WATER WORKS<sup>1</sup>

## By T. HOWARD BARNES

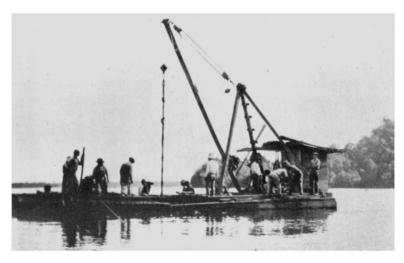
CATAMARAN EMPLOYED IN LAYING SUBMERGED PIPE
